Manhole Inspection Summary

Manhole # S43GG_033MH

Insp Date: **9/2/09 11:24 AM**

Location Address: **1334 BOND ST**

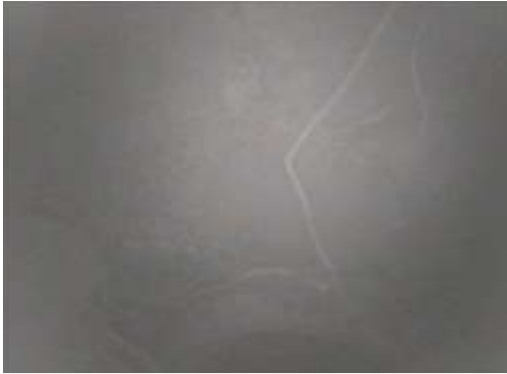
Defect 1

ROOTS IN BARREL

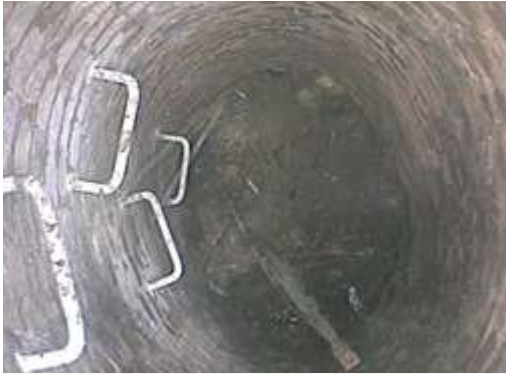
Defect 4

Condition: ☐ Sound ☐ Cracked ☒ **Root Intrusion** ☐ Deteriorated ☐ Leaks ☒ **Debris**

ROOTS AND DEBRIS

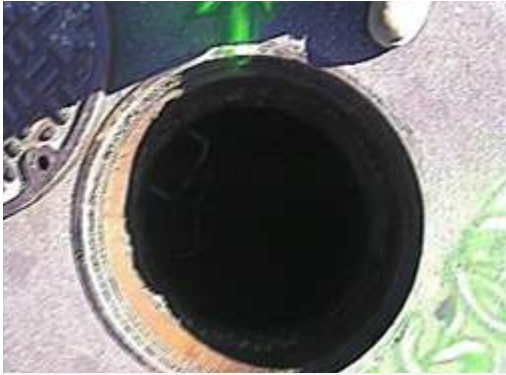
Defect 3

Offset: **2** (in.)

FRAME OFFSET

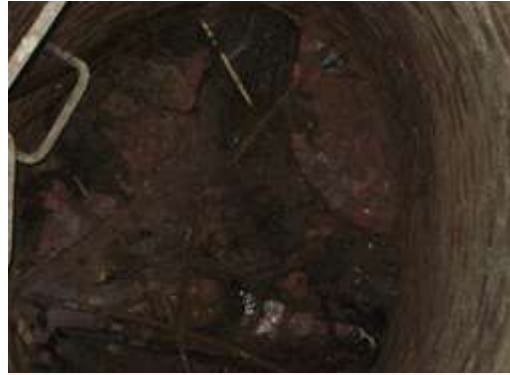
Defect 5

Condition: ☐ Sound ☐ Cracked ☒ **Root Intrusion** ☐ Deteriorated ☐ Leaks ☒ **Debris**

CHANNEL FULL WITH DIRT AN ROOTS

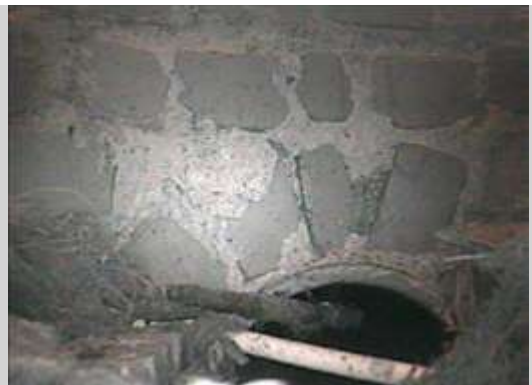
12 O'Clock Outflow

DEBRIS AND ROOTS IN CHANNEL

Deposits: ☐ None ☐ Mud ☐ Sludge ☒ **Debris** ☐ Grease

Silt Depth: **0** (in.) Deposits Extent: **Heavy**
